Special Edition 13/2004
Special Steel Pipeline Technology

Long term experience with DENSOLEN-Tapes

Excavation of 27 year old pipeline segments protected with DENSOLEN-Tape S40

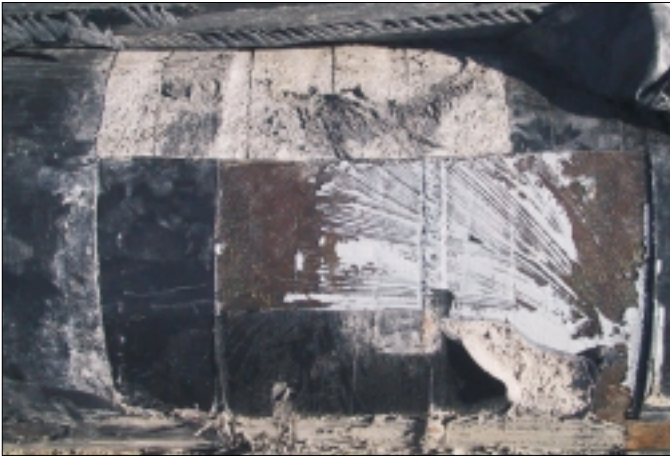
Fig. 4: Partly peeled off welded joint DN 300 with DENSOLEN-System S40

The outstanding long term behaviour of DENSOLEN-Tape S40 is now being demonstrated by peel strength tests carried out on the dismantled pipe segments, which is exemplarily shown in **Figure 4** to **Figure 7** exemplarily.

Regarding the welded joint in **Figure 4** it has to be noticed that the adjacent factory coating does not show any traces of surface preparation and roughening. Therefore the tape could be peeled off from the smooth polyethylene surface without any residues of adhesive, which nevertheless required high peel strength values of 13 to 16 N/cm at 10 mm/min peel speed. According to common procedure in 1976 for pipe diameters smaller than DN 500 [6], the transition from steel to factory coating had not been bevelled. Consequently a 3 to 4 mm wide hollow exists under the tape wrapping (**Figure 5**). Nevertheless, rust formation could not be observed. Such hollows would be critical even in case of cathodically protected pipes, if circu-
