Pipeline Rehabilitation with DENSOLEN-Tape System

For choice of a suitable coating material for pipeline rehabilitation, both technical performance and conditions of application have to be considered. The subsequent report of coating refurbishment on bellhole segments of a 40" oil-pipeline shows, that state-of-the-art DENSOLEN plastic tape systems offer a high performing and easy to apply method for coating refurbishment.

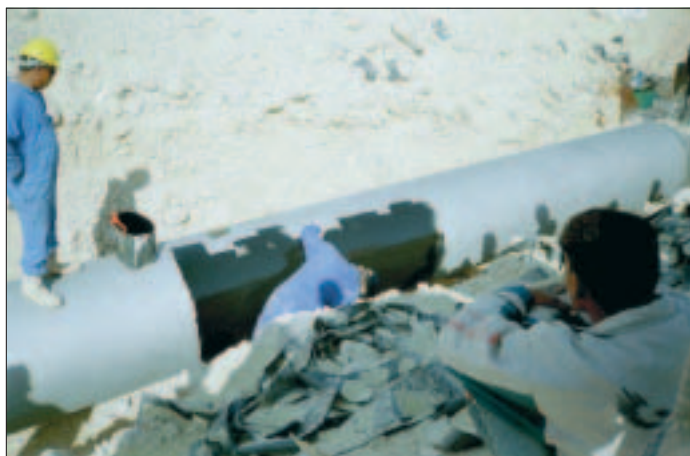
Fig. 1: Primer application by roller

Due to the short segment type of rehabilitation and due to the small pipe clearance, the DENSOLEN-Tape system was applied manually. Application of DENSOLEN-Primer MT25 was done by roller (**Figure 1**). Primer MT25 contains a special, less volatile solvent, which allows suitable drying times even under elevated ambient and pipe surface temperatures.

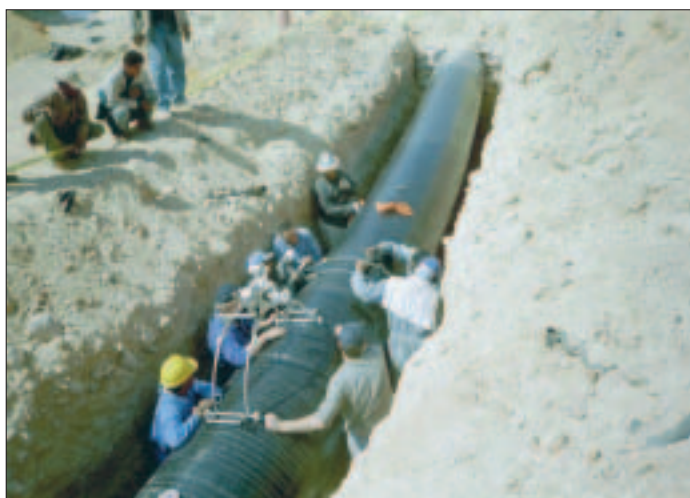
Fig. 2: Tape wrapping with DENSOMAT KGR Junior with extension arms

To ensure a constant tape tension and tape overlap, the subsequent tape wrapping was carried out with DENSOMAT KGR Junior hand wrapping machines. For the same reason, tape width was limited to 100 mm. By using tape rolls of up to 70 m (AS39P) and 100 m (R25HT) length, these wrapping machines require a minimum pipe clearance of

For use on the big 40" pipe diameter, the DENSOMAT KGR Junior was initially equipped with low weight extension arms (**Figure 2**). In a later stage a modified "cage"-DENSOMAT KGR Junior (**Figure 3**) was employed, which allows a proper handling of the wrapping machine even under restricted trench width conditions.

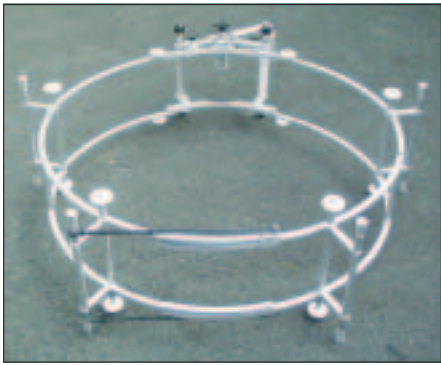
Fig. 3: cage-DENSOMAT KGR Junior with low weight aluminium frame
