Michael Schad, DENSO GmbH, Germany, presents a case study on corrosion prevention tapes in use on the MONACO gas transmission pipeline.

The MONACO transmission pipeline – 87 km long, DN 1200 nominal diameter and approximately 5000 weld seams – is located in Upper Bavaria in Germany. The new construction of the high-pressure natural gas line is an important milestone for security

SUITS OF TAPE ARMOUR

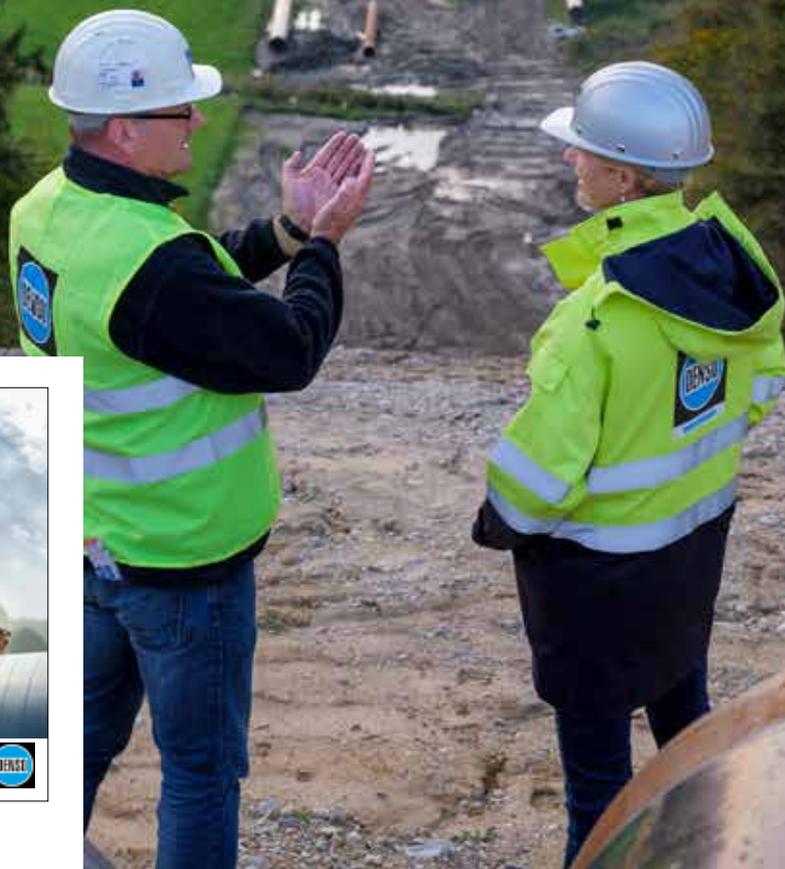
Figure 1. MONACO steep slope, Germany.

The varying terrain along the supposedly short building section of the MONACO pipeline, which measures approximately 40 km, presents an enormous task. A number of rivers, train lines, road crossings and – as a particular challenge – a steep slope with a gradient of 50% need to be conquered. People, materials and machines must be able to meet very stringent requirements when welding the tubes and subsequently insulating the weld seams on the slope (Figure 1).

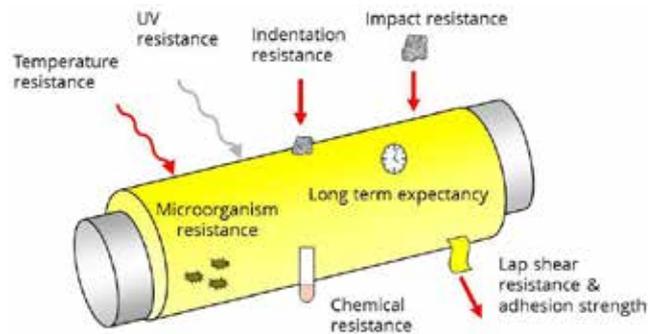
Figure 2. External factors for field joint coating.

As with every other construction site, the challenges on the MONACO pipeline are very specific and unique. Unlike with a factory coating – where the steel pipes are coated with a protective system under ideal production conditions – during field joint coating, highly dynamic, sometimes very difficult external factors need to be taken into account on the construction site itself. Important factors during installation are characteristics specific to the respective climate, soil and terrain. In contrast, for operation of the pipeline itself, protection against corrosive media and the pipeline’s resistance to mechanical stresses such as transport and pipe movements are particularly important.

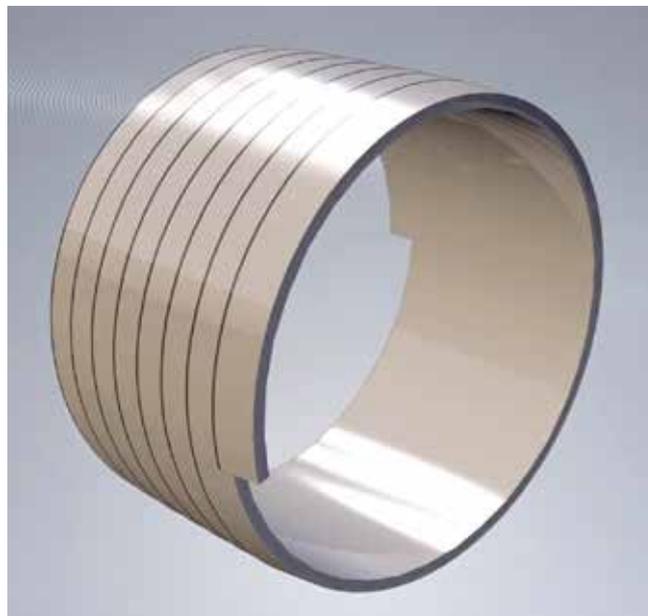
Figure 3. Permanent hose protection.

A spiral-shaped wrapping with 50% overlap of the three-ply tapes around the pipe allows the butyl adhesive layers to amalgamate in the overlap areas. They form a homogeneous, hose-like coating and are inseparably connected to each other. In these areas the molecules of the butyl-rubber layers fuse together. This self-amalgamating process is completed after only a short amount of time – five days at the most (Figure 3).

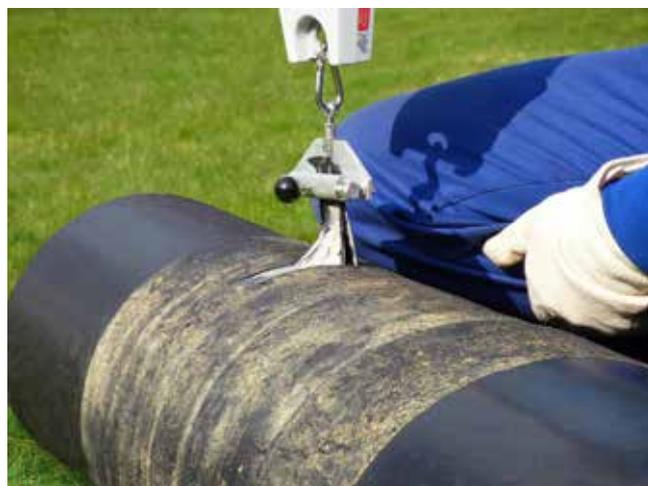
Figure 4. Cohesive separation pattern after 39 years.

In 1976, the tape was applied with a standard specification for peel strength of 8 N/cm in accordance with DIN 30672. The current standard testing in accordance with EN 12068 requires a higher peel strength of 10 N/cm. After 39 years, measurements showed a cohesive separation pattern with a phenomenal peel strength of 18.3 N/cm. The results of the analysis therefore exceed today's requirements by 83% (Figure 4).

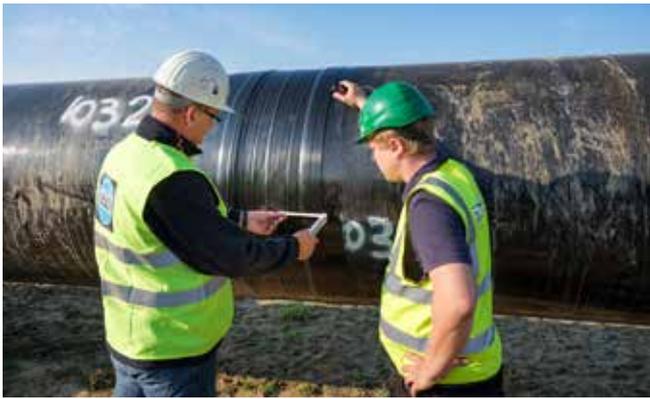
Figure 5. Quality inspection of the overlap width.

fuelled or electric driven DENSOMAT-11 wrapping machines guarantee a high level of application reliability, and automatically maintain a constant winding tension and overlap width (Figure 5). Three of these machines are used on the pipeline. Bert Bockstaele, Head of QSHE at DENYS, emphasises that using the equipment, the employee workload is significantly reduced. "The wrapping machines make us 50% faster and therefore more productive compared to manual wrapping. On one day we coated 53 weld seams," Bockstaele said.

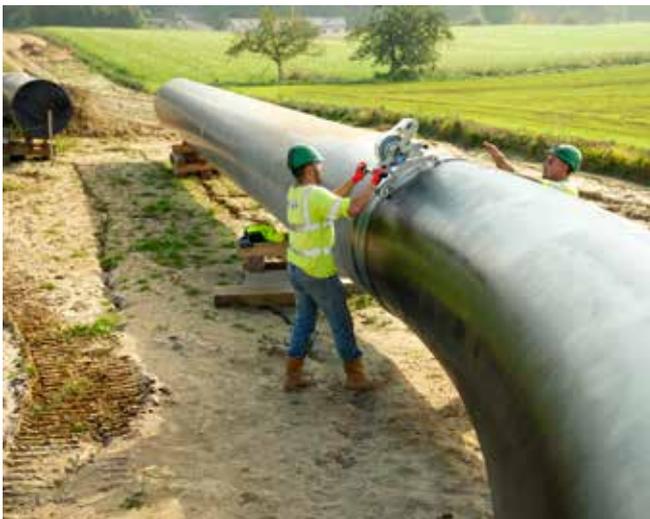
Figure 6. Processing with DENSOMAT®-KGR.

The smaller, manual wrapping device DENSOMAT-KGR Junior is light and extremely flexible. For this demanding project with steep slopes, train and river crossings, as well as road crossings, it can be used in many different ways. Because of its lightness, the device is ideally suited for use in difficult-to-access terrain, such as on the steep Wanklbach slope, but also for the field joint coating of short pipe elbows and for short nominal widths of DN 40, for example in station construction (Figure 6).
